Restoration of the Echelsbacher Bridge in Germany

After its completion in 1929, the Echelsbacher Bridge in the alpine foothills of Bavaria (Germany) was an internationally renowned engineering achievement. Built in the Melan design, this was the largest Melan-type arch bridge of its time. Due to environmental influences over time, the bridge has reached an unsafe and structurally hazardous state. This paper describes the history and the details of the bridge and the investigations carried out for its structural safety verification. It was shown that this structural heritage has reached the end of its life cycle; therefore, the decision was made to replace it. The new bridge design well integrates this historical and technical monument.

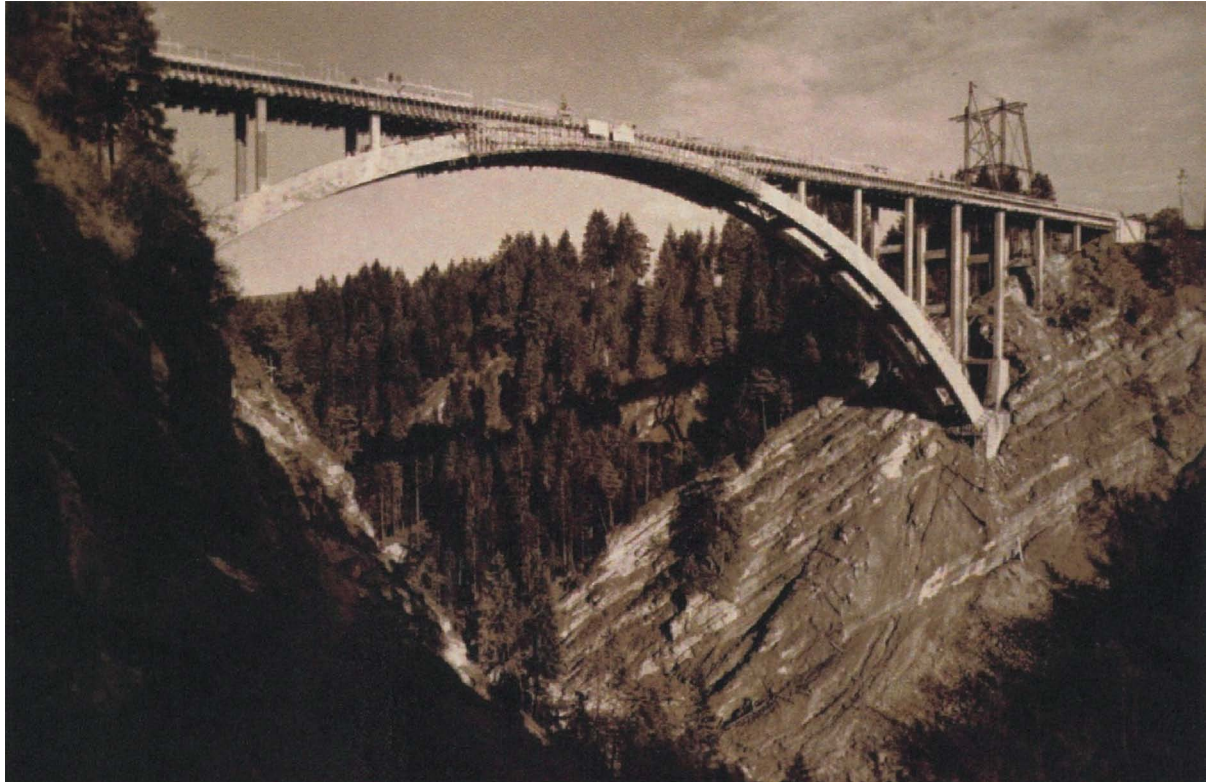
Figure 1. Echelsbacher Bridge just before completion (Düll and Gerhardt, 1931)

The central element of the design was a 130 m wide reinforced-concrete arch with a stiff reinforcement. This construction, known as Melan construction, describes a concrete cross-section with an integrated steel framework, which is initially used as the bridge's falsework. The Echelsbacher Bridge was the largest Melan-type arch bridge in the world (Figure 1).

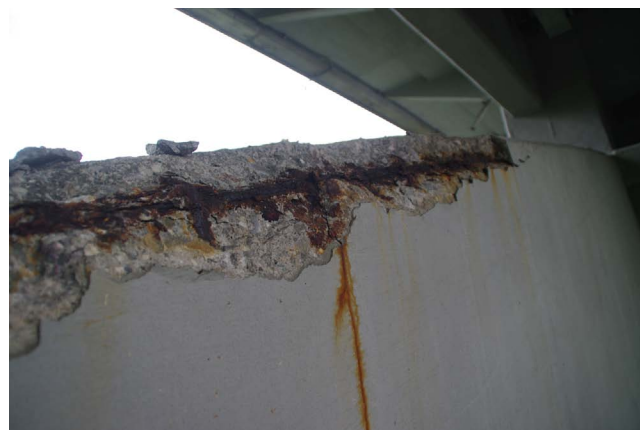
Figure 7. Example of damages to the arches

The areas of damage are distributed across the entire structure. The damages include concrete spalling; delamination of the concrete cover exposing the reinforcement; corrosion of the steel rebars (in some places, completely dissolved the cross-section of the rebars); and corrosion of the steel framework with a significant reduction of the steel cross-sections.

The most recent inspection was in the summer of 2015. An increase in the number of defects was documented. The continuing deterioration of the structure was obvious (Figures 7 and 8).

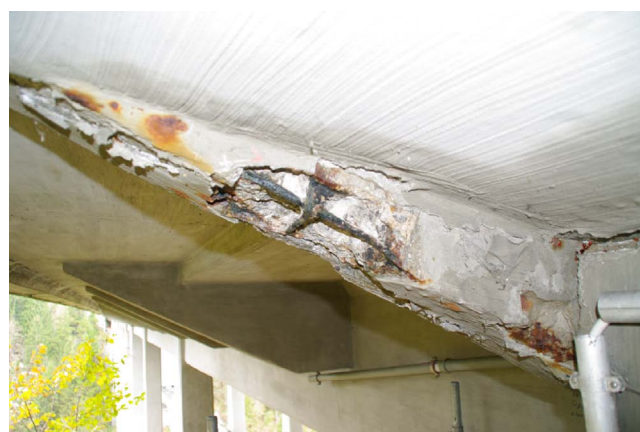
Figure 8. Damage to the console of the cantilever slab

Another critical issue concerns the cantilever beams, which were installed in 1963. These are critical because the consoles were installed only by single steel rebars, and there is no redundancy for failure. Other critical issues are the connections between the braces and the arches because the reinforcement is certainly insufficient and concrete spalling will lead to a reduction of stability and load capacity.

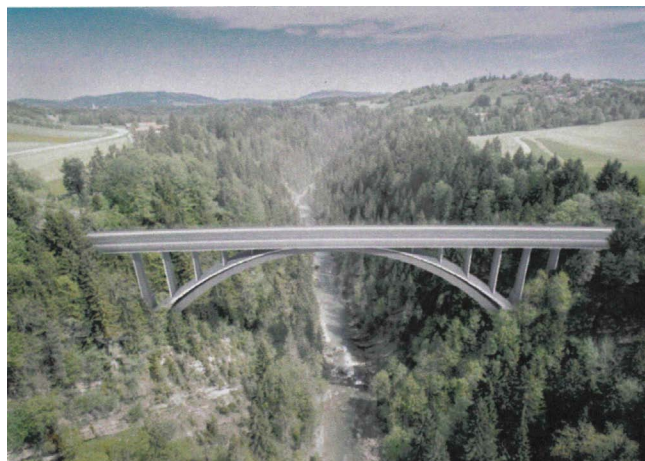
Figure 10. The new Echelsbacher Bridge (Dr Schütz Ingenieure, Kolb Ripke Architekten, Narr Rist Türk Landschaftsarchitekten)

The winners of the first prize were Dr Schütz Ingenieure, Kolb Ripke Architekten and Narr Rist Türk Landschaftsarchitekten. This team of designers excelled with the innovative idea of incorporating the arches of the old bridge in a comprehensive concept and integrating them in an environmentally friendly manner (Figure 10).
